# **Results of Field Monitoring Prototype Floorbeam Connection Retrofit Details on the Birmingham Bridge**

**Final Report**

**ATLSS Report No. 04-04**

**February 2004**

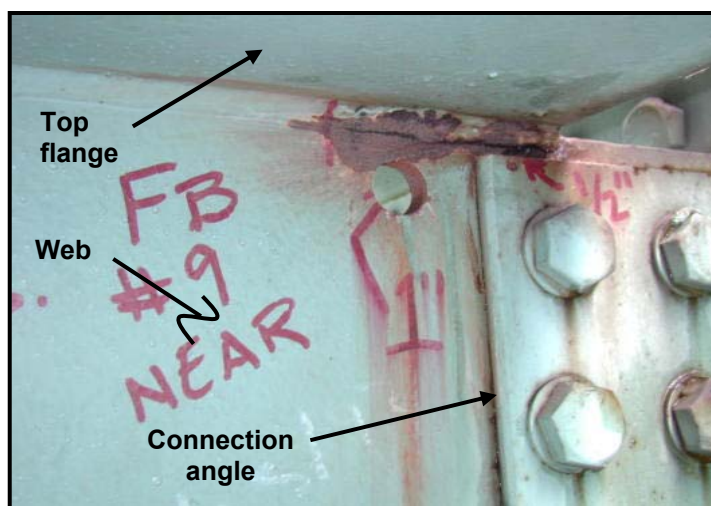
Over the past several years, fatigue cracks have been found in nearly all of the transverse floorbeams at the connection to the tie girders. Specifically, horizontal cracks, some of which have several branches, have been reported at the upper web/flange weld in the web gap between the top flange and the connection angles. A typical floorbeam crack is shown in Figure 2. The floorbeams are spaced at 31'-0" and are 112" deep.

Figure 2 - Photograph of typical crack in floorbeam at connection to tie girder.

The cracks observed in the Birmingham Bridge originate and propagate parallel to the top flange. Many of these cracks are several inches long. At some locations, the crack was observed to branch and turn downward into the floorbeam web. The field instrumentation has confirmed that the cracking is the result of relative longitudinal displacement that occurs between the floor system and the tie girder. This deformation could be visually observed at several of the cracked areas. The displacement introduces out-of-place movement within the web gap above the connection angles. Although the magnitude of the displacement is very small, it is concentrated within the small web gap. The restraint provided by the top flange and the connection angles on the web force the section of the web within the small web gap to bend in double curvature. The displaced system is shown schematically in Figure 3.

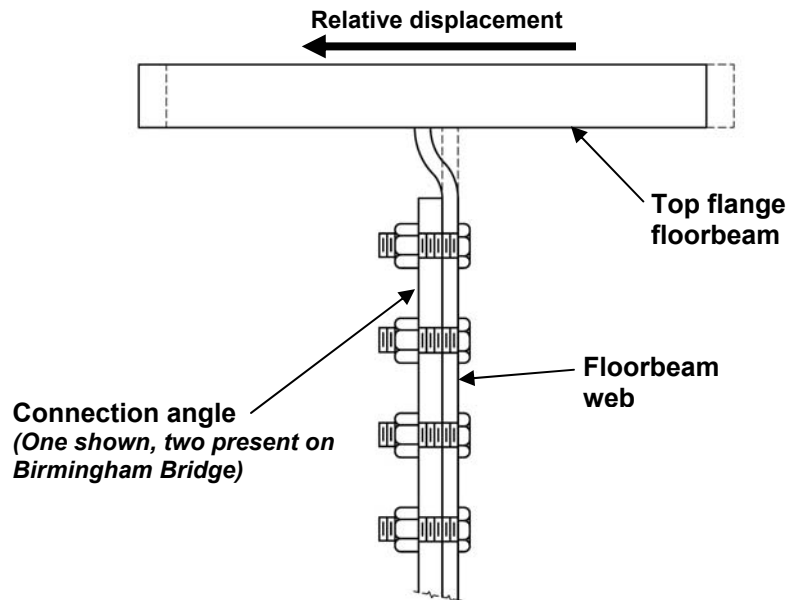
Figure 3 - Schematic showing distortion of typical floorbeam web gap

The longitudinal displacement range is comprised of the global deflection of the bridge and local deflections/rotations due to trucks passing in the adjacent floorbeams (*i.e.*, *live load*). Because the displacement is related to the global deflection of the bridge, free vibration of the structure produces the necessary driving force. Hence, multiple cycles are accumulated during the passage of a single truck. This behavior was observed while on site by placing a finger on an active crack. The crack surfaces “moved” relative to each other in the longitudinal direction. The movement was constant, no matter what longitudinal or transverse positions the vehicles were in.

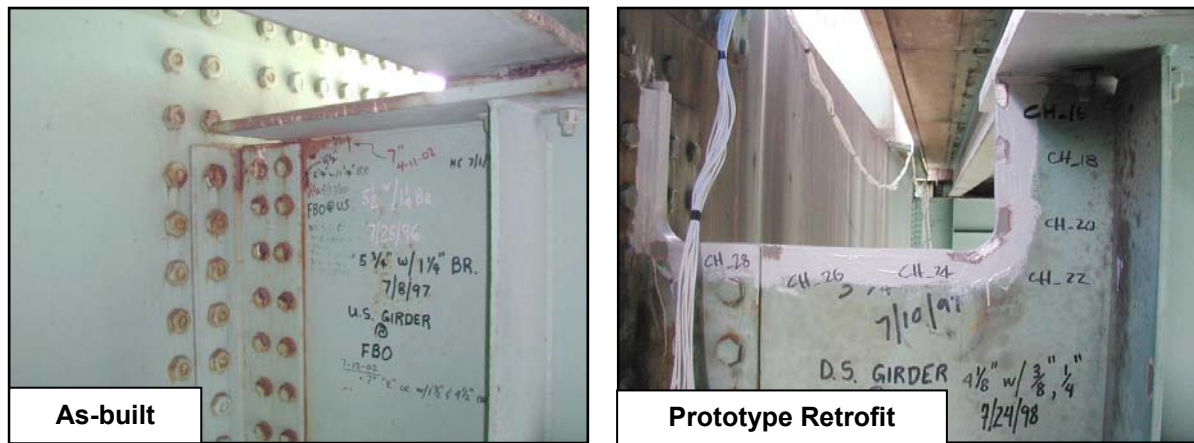
Figure 4 - Photographs of as-built and prototype retrofit floorbeam connections

In order to evaluate the performance of the proposed retrofits, the upstream and downstream connections at floorbeam 19 were retrofit and instrumented. Figure 4 contains photographs of the as-built condition and the prototype retrofit details. The as-built geometry of the retrofit is shown in the detail drawings in Appendix C.

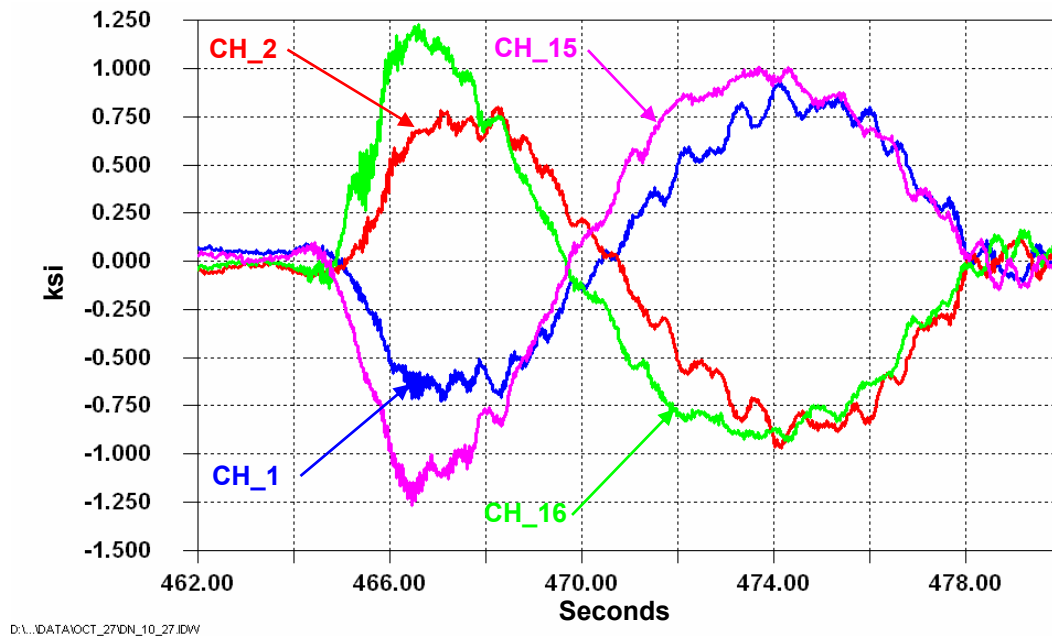
Figure 21 – Response at Web-to-flange weld at upstream and downstream connections of Floorbeam L19

- Comparing the response of the back-to-back gages clearly reveals that the response is primarily bending from longitudinal displacement. For example, comparing channel CH\_1 and CH\_2 indicates a nearly equal and opposite response throughout the time history. The same is observed for CH\_15 and CH\_16. This type of response is

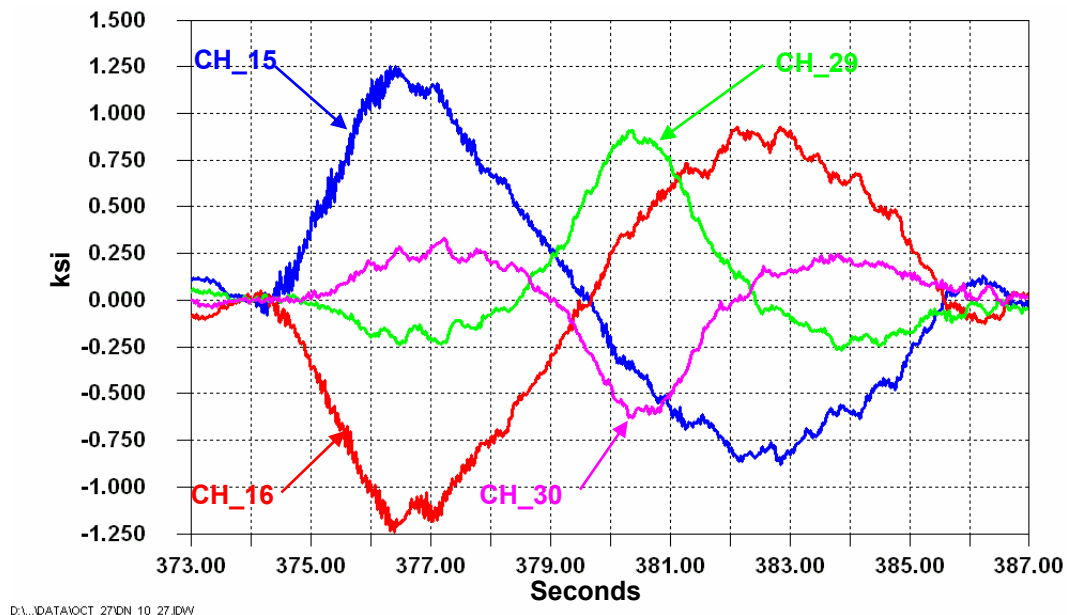
As the vehicle crosses directly over the instrumented portion of the tie girder, positive moment stresses are developed in the tie girder. However, (see Section 6.1), negative moments are also produced as the truck is approaching and after it passes the instrumented section. The effects of this reversal are also observed in the response of the floorbeam connection as a reversal in stress range at each gage.

Figure 22 - Comparison of vertical web stresses adjacent to web-to-flange weld with tie girder response

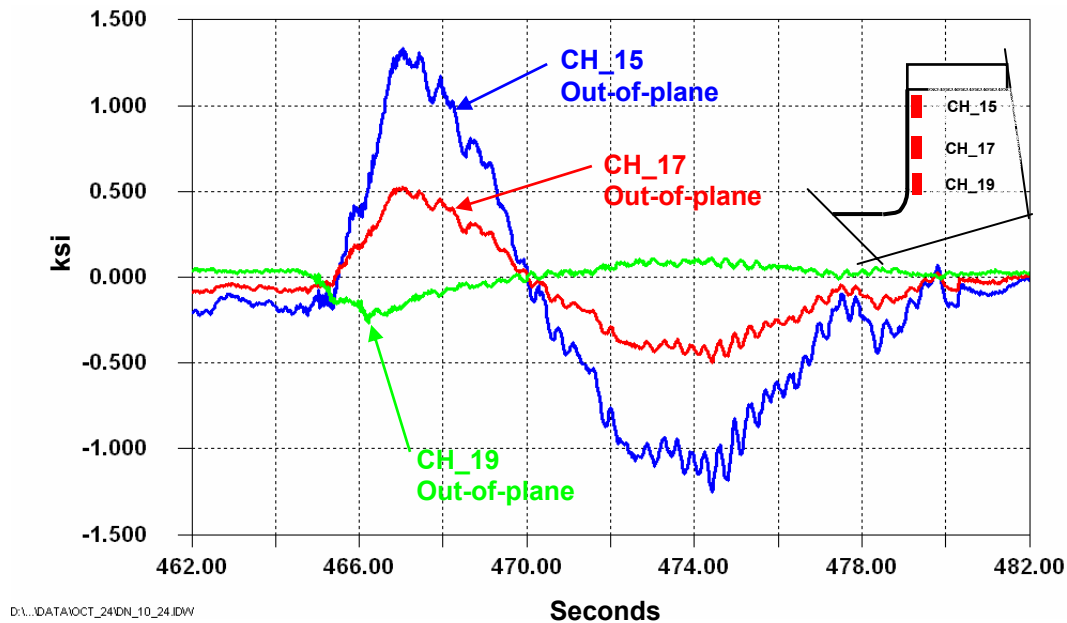
(vertical) and out-of-plane stresses were measured in this region. Figure 25 presents the out-of-plane bending components at each location along the length of the cut for the north face of the downstream connection. In other words the bending stress component at channels CH\_15, CH\_17, and CH\_19. As can be seen, the bending stresses decrease proceeding down along the cut and actually reverses in curvature. It is important to note that reverse curvature stresses are not observed until the area near the base of the cut is considered. This indicates that the retrofit condition is very flexible and does not offer much resistance to the longitudinal displacement. Note to that the stress-range cycle takes about 14 seconds to complete.

Figure 25 – Comparison of Out-of-Plane stresses along vertical cut at downstream connection

Review of Figure 25 indicates that in the region of channels CH\_19 & CH\_20 located near the bottom of the vertical cut, the out-of-plane stress component is very small. However, a comparison of the in-plane stress components reveals that in-plane stresses are greatest near the bottom of the cutout. This response is illustrated in Figure 27 which compares the in-plane or vertical stress component at each location along the vertical cutout. The increase in the vertical stress component toward the bottom of the cutout is expected. It can be seen that it is due to the vertical reaction of the stringer by comparing the length of time of the in-plane response with the total stress-range cycle, as shown in Figure 27. Notice that the length of time required for the in-plane stress-range cycle to occur is only about 3.2 seconds while the out-of-plane component, as illustrated with CH\_15 takes nearly 15 seconds. The reaction is maximized only when the load is in the immediate region above a given stringer, which only lasts for a relatively short period. For the data presented in Figure 27, the truck was headed south towards Carson Street. This is why the in-plane stress is maximized early in the stress-time history curve. A similar but reflected response is observed for trucks heading northbound.

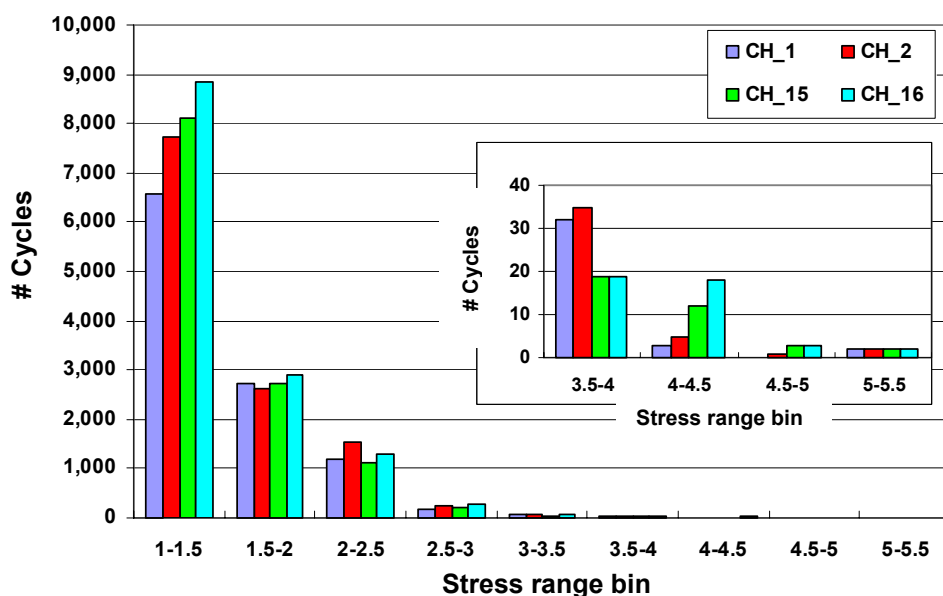
The fatigue resistance of the web-to-flange weld when subjected to vertical bending stresses can be characterized as a category C detail. The mode of crack initiation would be at the weld toe on the web, as demonstrated by the observed cracks at other floorbeams. The CAFL for category C is 10.0 ksi. As can be seen, there were no stress-range cycles measured which approached the CAFL. Hence the retrofit is effective and no further crack development would be expected.

Figure 28 - Stress-range histogram for channels CH\_1, CH\_2, CH\_15 and CH\_16 located adjacent to the web-to-flange weld of floorbeam 19 near the retrofit cutout

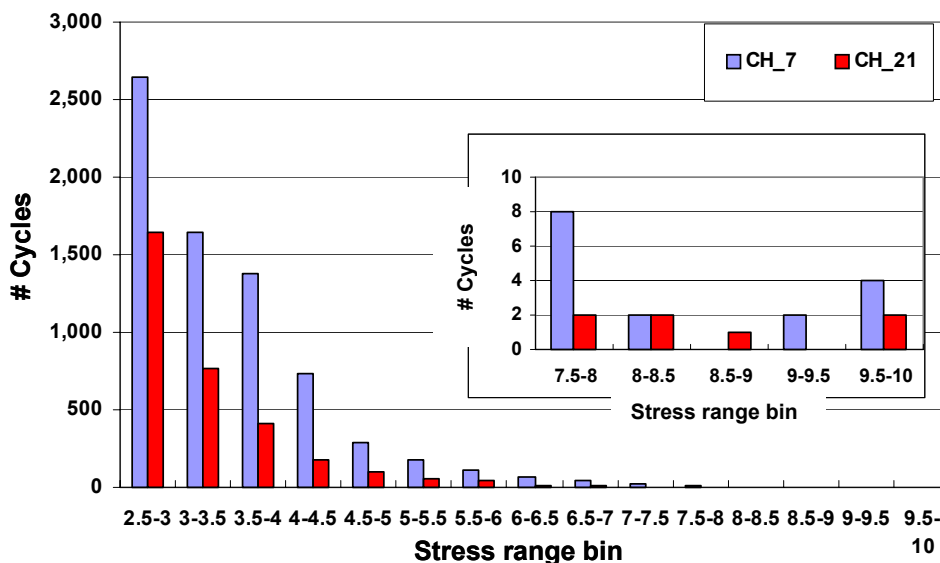
Figure 31 - Stress-range histogram for channels CH\_7 and CH\_21 located at the radius cutout

Table 7 summarizes the results of the long-term monitoring of channels CH\_7 and CH\_21. Because the radius of the cutout has been saw cut and ground smooth it is reasonable to compare the detail to the fatigue resistance of category A, which has a CAFL of 24.0 ksi. As indicated in Table 7, the maximum stress range of 10.0 ksi is far less than the CAFL, and no fatigue cracking will develop at the radius cutout.

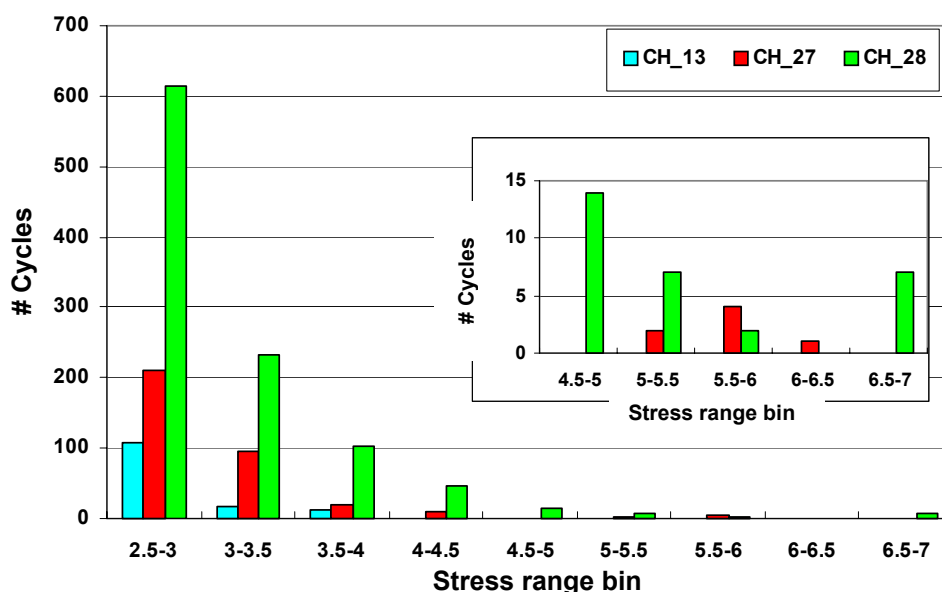
Of the four channels installed directly on the connection angles, three were included in the long-term monitoring program. These were CH\_13, CH\_27, and CH\_28 (*CH\_14 was not operational*). The stress-histogram for these gages, ignoring cycles less than 2.5 ksi is presented in Figure 33. The maximum stress range was measured at channel CH\_28 and was 7.0 ksi. There is no defined fatigue category for the surface of the connection angles in the fillet region subjected to local bending. However, this area is classified as a base metal condition (i.e., category A) when subject to stress ranges on the gross section. Since the measured stresses are on the surface and account for stress concentrations and local bending effects, it is reasonable to compare the measured stresses to the base metal condition. The CAFL for category A is 24.0 ksi. As can be seen, there were no stress cycles even approaching this value. Hence, cracking of the connection angles is not expected. Furthermore, there does not appear to be any need to remove the portion of the angles above the cutout that remain bolted to the face of the tie girder web to improve the performance of the retrofit.

Figure 33 - Stress range histogram for channels CH\_13, CH\_27, and CH\_28 installed at the fillet of the floorbeam connection angles
